CEEDO-TR-79-01

INDUSTRIAL WATER TREATMENT TECHNOLOGY TRANSFER TECHNIQUES AND MANAGEMENT

RUSSELL W. LANE CHESTER H. NEFF

ILLINOIS STATE WATER SURVEY P.O. BOX 232 URBANA, ILLINOIS 61801

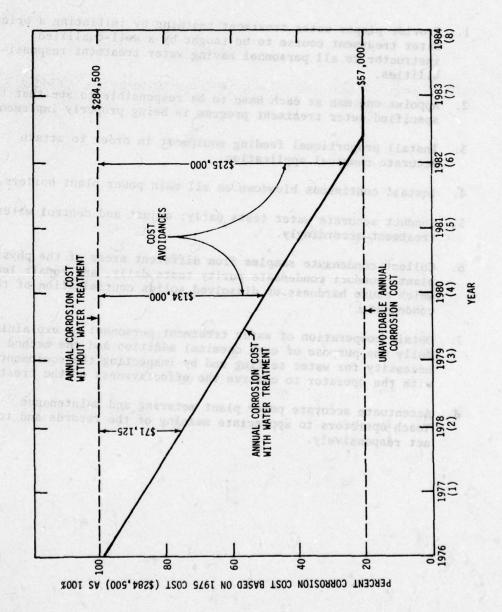
- b. During 1975 the estimated cost of condensate corrosion at Chanute AFB was determined to be \$284,500 as reported in AFCEC TR 77-17, Corrosion Costs of Air Force and Army Facilities and Construction of a Cost Prediction Model, Table 4, page 14. With this cost figure and the above rates a corrosion cost reduction or cost avoidance graph can be prepared as shown in Figure 2. In this case, the following assumptions were made:

- c. The purpose of Figure 2 is to illustrate that you cannot expect to stop all corrosion or to realize all cost savings immediately. The cost avoidances, though, continue as long as the corrosion control program remains in effect. The maximum cost benefits occur about six to seven years after effective water treatment is initiated. Conversely, if adequate treatment ceases, then it would take six to seven years before the full consequences could be realized.

Figure 2. Costs of condensate corrosion at Chanute AFB
